Technical Paper

Characteristics of Vinyl Ester Laminates Suitable for Chimney Liner Applications after High Temperature Thermal Stress

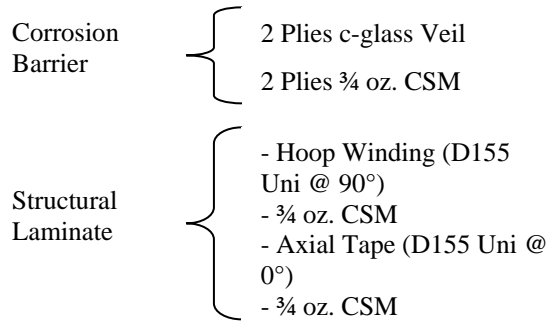
Figure – 1

Note: the structural laminate reinforcement sequence is repeated approximately 8X until a 0.5" thick laminate is achieved

The reinforcement schedule was chosen to represent that of a typical chimney liner and is represented in Figure 1. In this study D155 (15 oz/yd² unidirectional) glass was used to represent the hoop windings due to its similar weight and thickness.

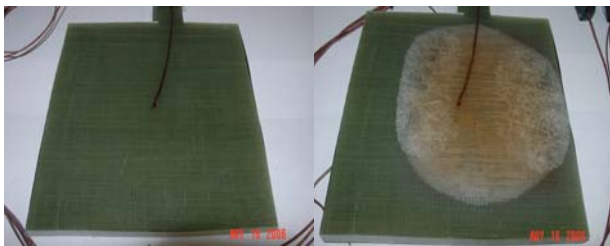
Figure – 3

Brominated Bisphenol A Epoxy Vinyl Ester (BBVE)
Before After Thermal Stress

Both resins experienced some discoloration during the high temperature chimney liner thermal stress tests as indicated by the before and after photographs (Figure 3 and Figure 4). Some delamination was evident around the embedded thermocouples, but it was localized and did not breach the corrosion barrier. The subsurface blisters are due to air entrapment around the thermocouple wires, large differences in thermal expansion between the wires and the laminate, and micro-voids around glass fibers formed during hand lamination. Trim pieces of the same laminates without thermocouples exhibited significantly less blisters when exposed to the same thermal stress profiles, (Figure 5). Clearly, the importance of void-free laminates in high temperature applications can not be overstated.

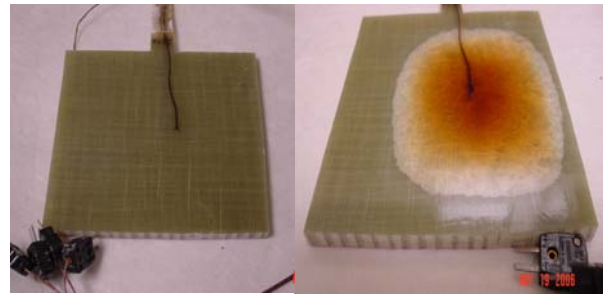
Figure - 4

Brominated Epoxy
Novolac Vinyl Ester (BNVE)
Before After Thermal Stress

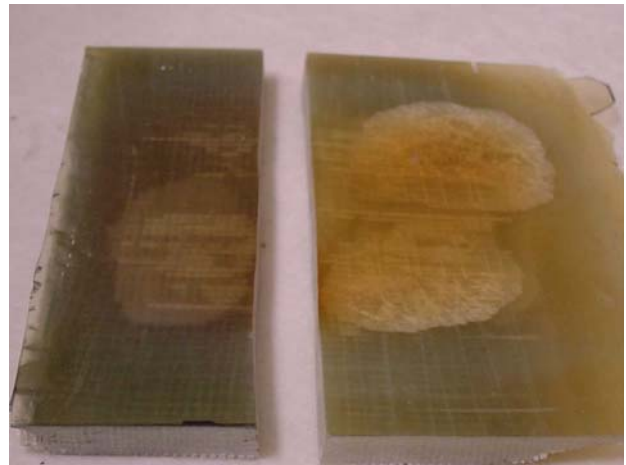
Figure – 5

Brominated Epoxy VE Brominated Epoxy Novolac VE
Both after Thermal Stress w/o Thermocouples

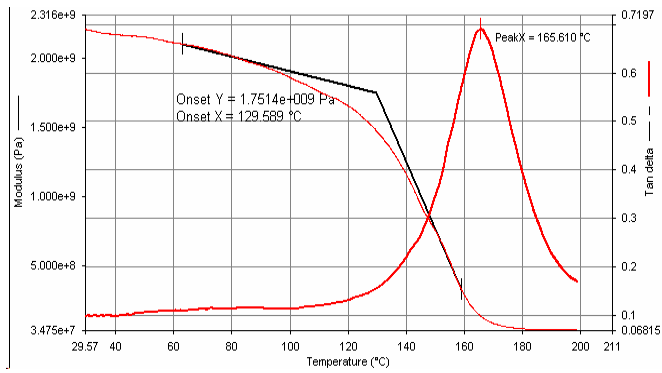
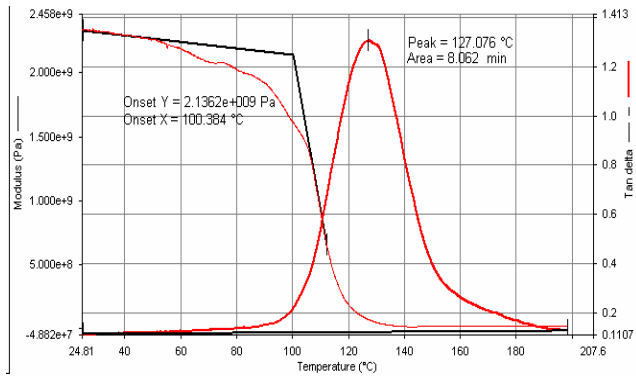
Figure - 6

Brominated Epoxy Novolac VE DMA Scan

Brominated Epoxy VE DMA Scan

The glass transition temperature (T_g) is a fundamental property of thermosetting resins. This temperature represents the point above which the resin reversibly transitions from a glassy solid to a rubbery semi-solid. While T_g can be measured by many different methods with each reporting a slightly different value, these values were derived from the peak of the tan delta curve from the DMA, (Figure 6).

The heat distortion temperature can be approximated from the average of the glass transition temperature and the onset of the glass transition temperature obtained from the storage modulus and tan delta curves (Figure 6).

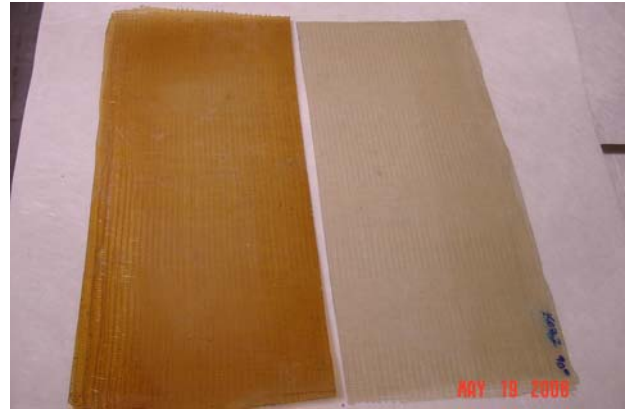
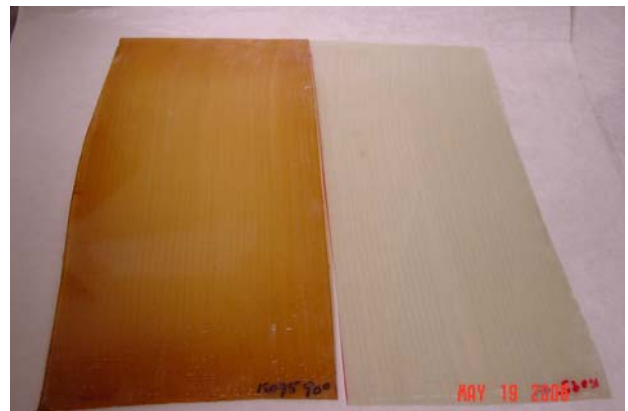
Figure - 7

After Bake Before
Brominated Epoxy VE

After Bake Before
Brominated Epoxy Novolac VE

Unidirectional fiberglass laminates prepared with two plies of 15 ounce/yd² of unidirectional glass fiber of each vinyl ester were evaluated by Dynamic Mechanical Analysis before and after a bake at 500°F (260°C) for 30 minutes. While both resins did exhibit some discoloration at these temperatures (Figure 7), they did not degrade as evident by the following data comparison in Table 6.
